Weight Handling Equipment Technical Bulletin
<http://ncc.navfac.navy.mil>

34th EDITION - Web Version
Editor: (610) 595-0905 or DSN 443-0505

June 2002

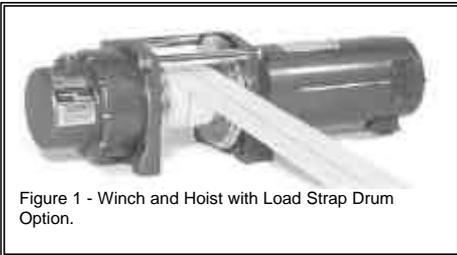
New versions of hoists, using a high strength synthetic strap rather than wire rope, for load handling are now available. In addition to being easier to handle, inspect, and install, straps eliminate load rotation problems associated with wire rope. Unlike wire rope, the strap winds smoothly in multiple wraps onto itself, which allows for a shorter drum. (See figure 1.) Straps do not require lubrication and they do not chip or spark.

All of the standard units are either AC electric or pneumatic drives. The units are adaptable to the needs of virtually any type of industry. The hoists have a factor of safety of at least 5:1. Hoist capacities of up to 5,600 pounds are available. Hoist speeds can be as high as 45 fpm and lifts can be as high as 30 feet. Attachments used for lifting are rings or crane hooks. Other custom attachments are available upon request.
